KEYSTONE HOME INSPECTIONS

Inspection Report

Prepared For:
Mountain Cove Home Owner's Association
Enid Grigg President

Property Address:
4594 Weldon Drive
Snellville, GA 30039

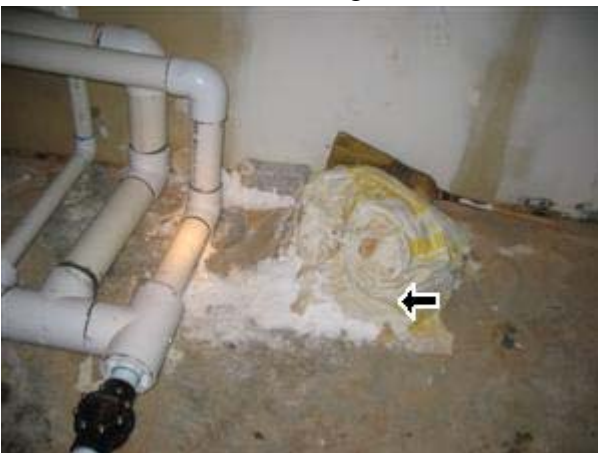
1.1 Picture 1

1.1 (1) There is a broken bag of chlorine in the pump area of the basement. Remove the chlorine.

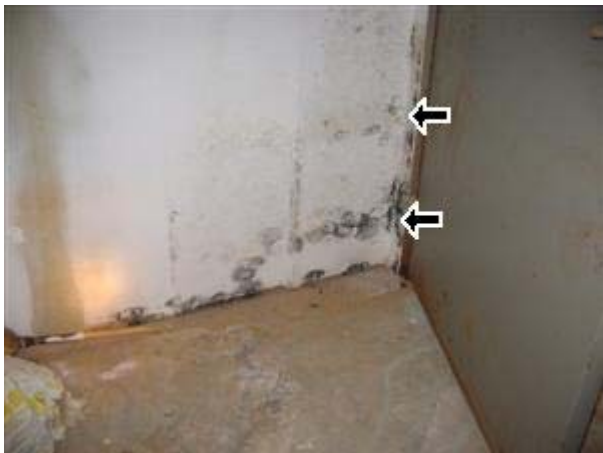
1.1 Picture 2

(2) Signs of mold growing on the walls in the basement. A fan has been installed in the pool pump room and is operating.

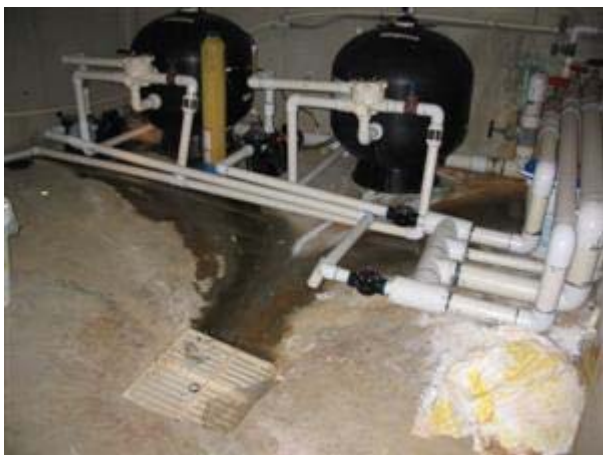
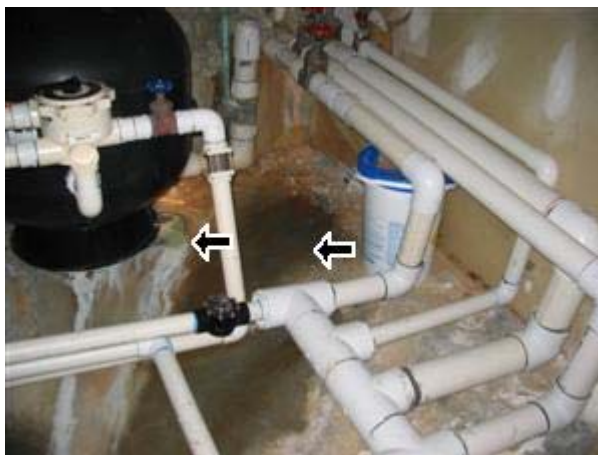
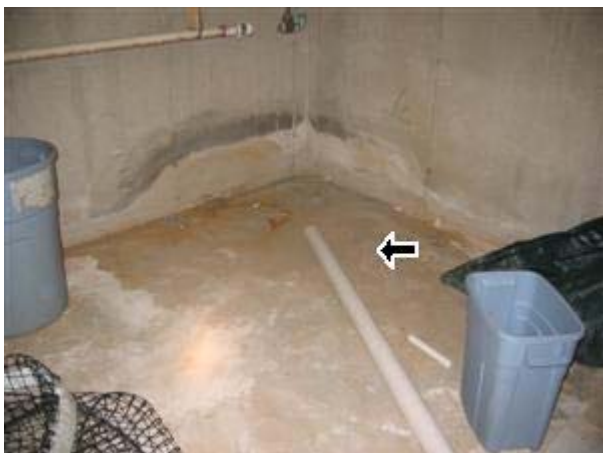
1.3 There is water on the basement floor in the pool pump area at this time. The source of the water appears to be from the pool filters. Have a Pool Contractor review and recommend repairs or replacement to the filters.

There is some dampness in the front right corner of the basement, under the Men's bathroom.

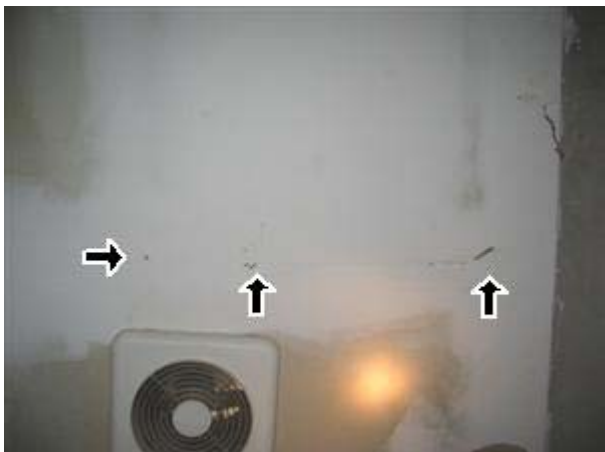
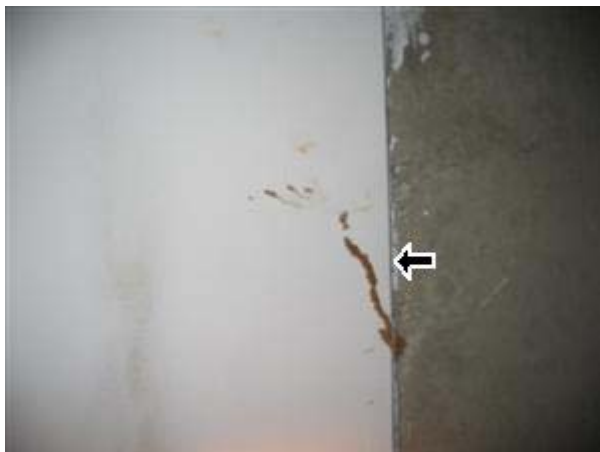
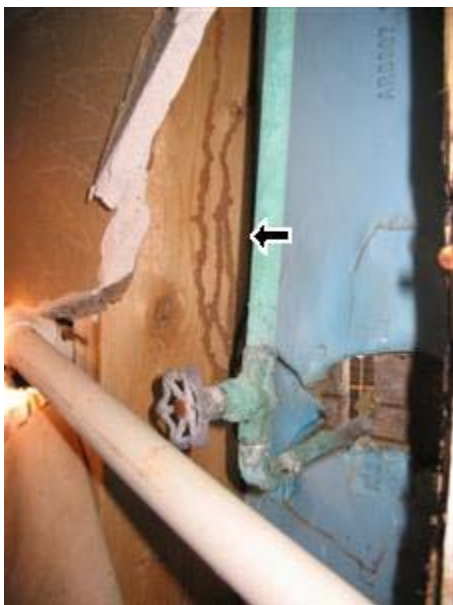
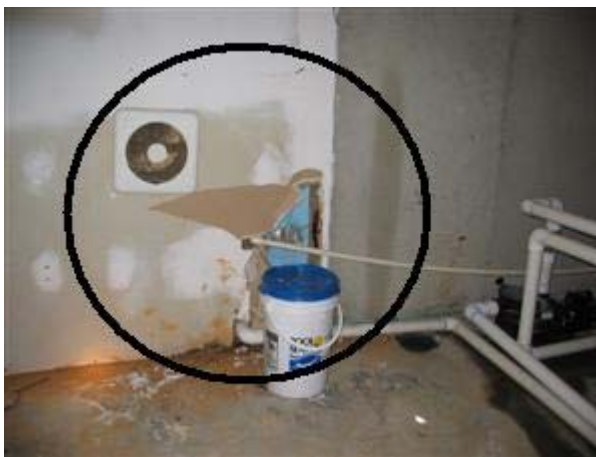
Signs of termite presence in the frame wall of the rear of the building where it meets the foundation wall, in the pool pump room. There is some damage to the wall framing visible at this time. I do not see any signs of current activity, but there have been no known repairs or treatments to this area to my knowledge.

1.4 Signs of termite presence in the frame wall of the rear of the building where it meets the foundation wall, in the pool pump room. There is some damage to the wall framing visible at this time. I do not see any signs of current activity, but there have been no known repairs or treatments to this area to my knowledge.

Contact a pest control Contractor to review and treat the area for termites.

Recommend removing the drywall up to a point where is it is evident that there has been no activity. Review the framing and repair as needed.

Recommend removing the drywall up to a point where is it evident that there has been no activity. Review the framing and repair as needed.

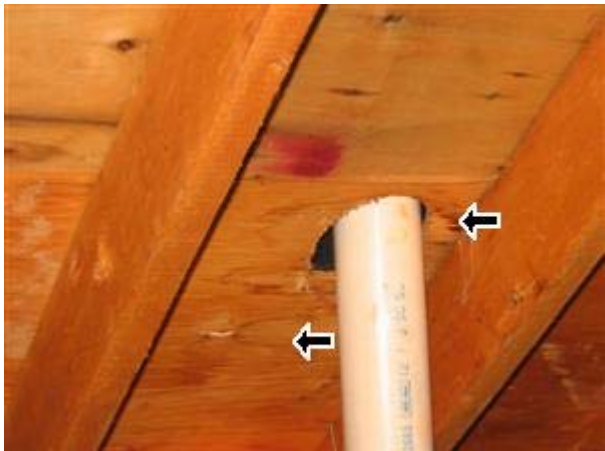
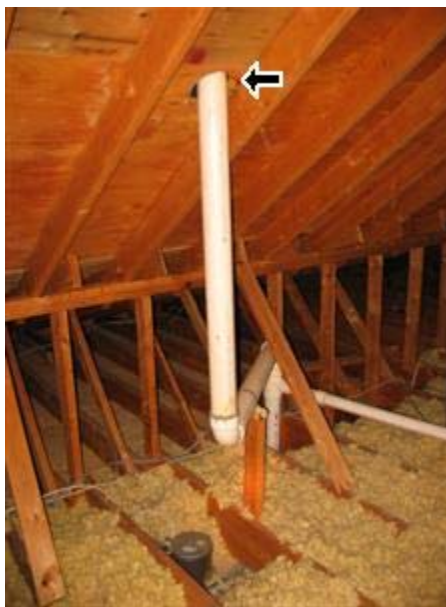
(1) Water stains in the roof decking visible over the light in the hallway with the water cooler. This stain is dry at this time. The plumbing vent flashing boots have been replaced recently.

1.7 (1) Water stains in the roof decking visible over the light in the hallway with the water cooler. This stain is dry at this time. The plumbing vent flashing boots have been replaced recently.

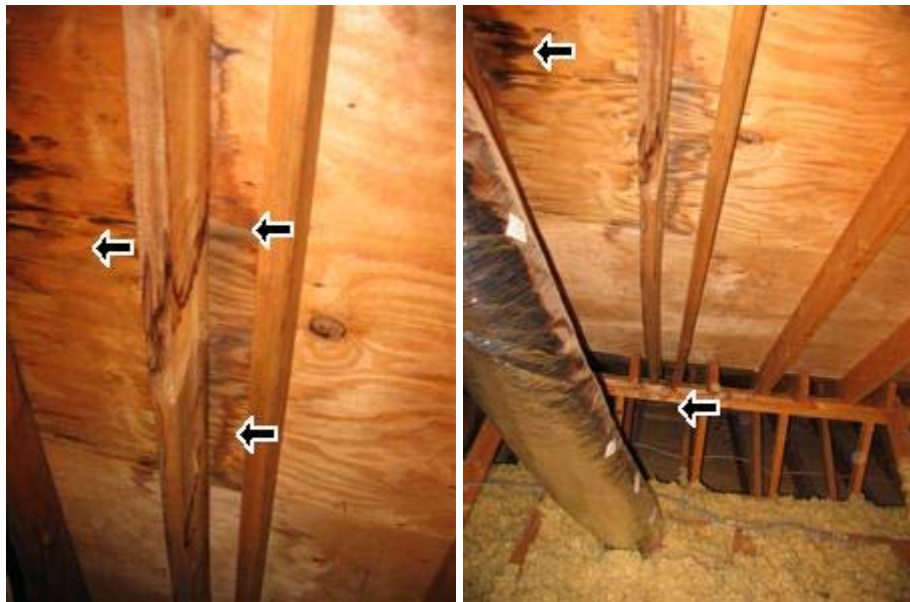
1.7 Picture 3

(2) Water stains in the roof decking over the door in the meeting room near the closets. The stain in the roof decking is wet at this time. This leak is from the aging roof shingles.

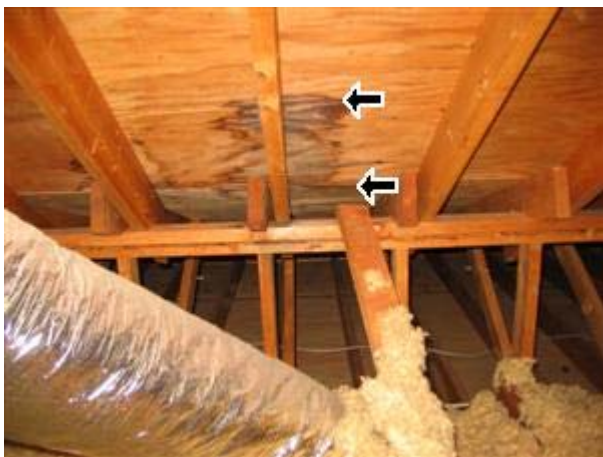
1.7 Picture 5

(3) Water stain in the roof decking over the meeting room door at the right rear corner of the building, on the rear wall. The stain is dry at this time. There is no roof penetration in the area, and there are not signs of past repairs on the roof in this area.

I estimate that this roof leak is still active. It is due to the aging roof shingles.

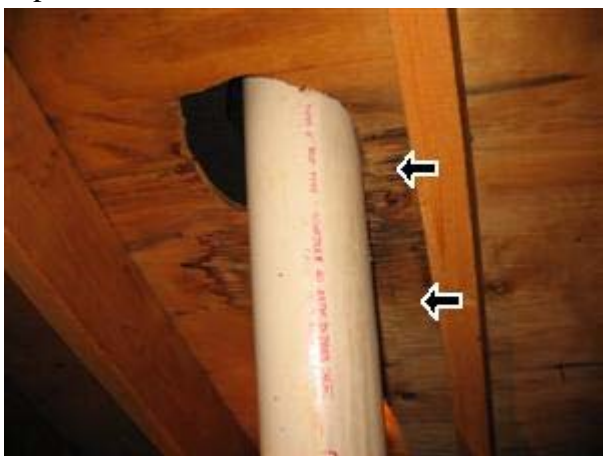
1.7 Picture 6

(4) Water stains in the roof decking at the plumbing vent over the Women's bathroom. The stain is wet at this time. Although there is a relatively new flashing boor around this pipe on the roof, water is still getting to the decking. Repair.

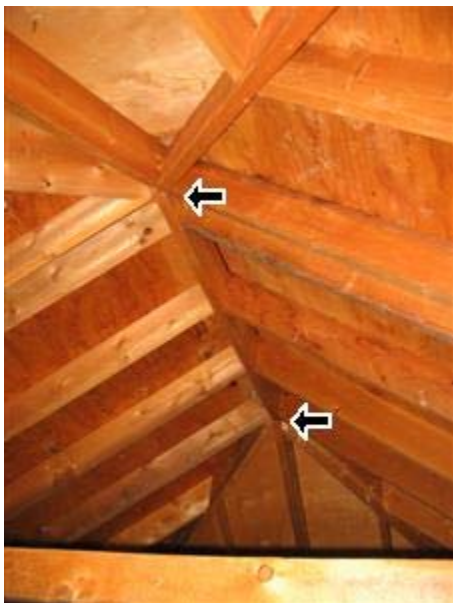
1.8 Picture 1

1.8 There are no ridge poles in the roof framing. This does not appear to have caused a problem at this time.

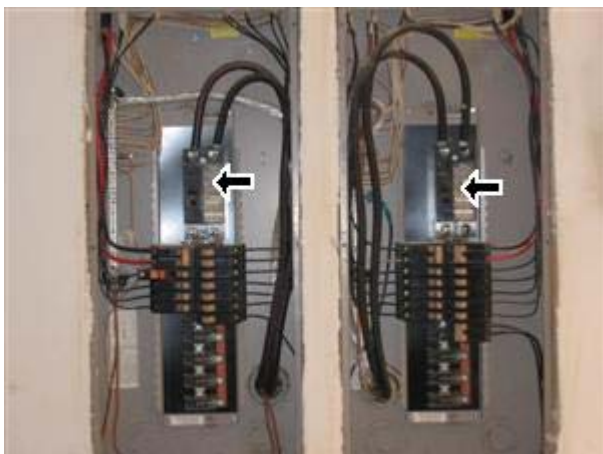
2.3 Picture 1

2.3 The main power shut off switches are located in the panel box. For Your Information.

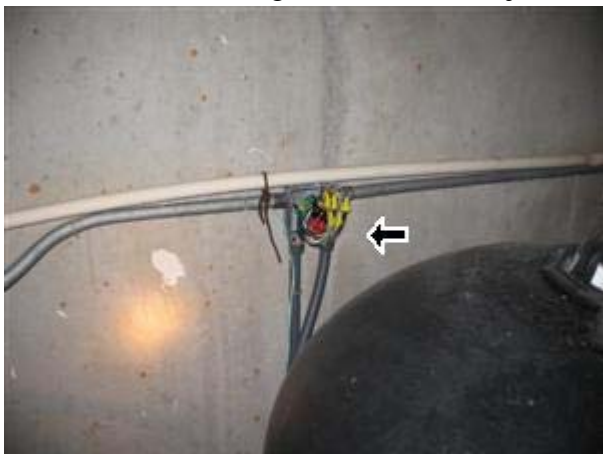
2.9 Picture 1

Open junction box in the pool pump room of the basement. This is an area that now has water on the floor. Recommend installing a cover over the junction box.

2.9 Open junction box in the pool pump room of the basement. This is an area that now has water on the floor. Recommend installing a cover over the junction box.

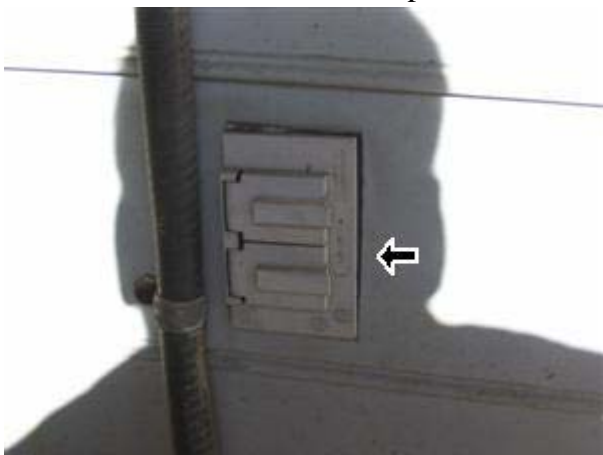
2.10 Picture 1

2.10 The exterior outlets on the porch are not covered with an exterior cover. Recommend changing the covers.

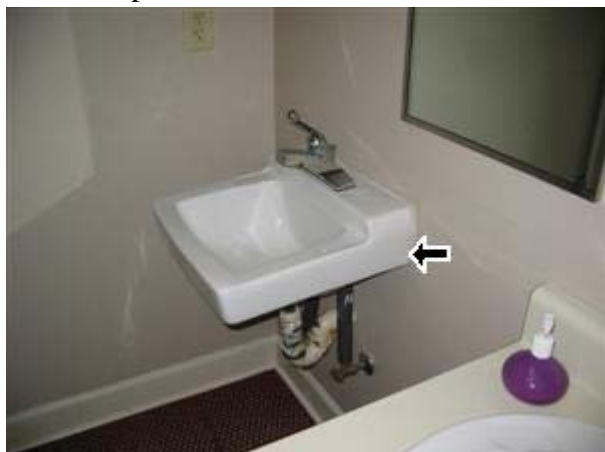
4.1 Picture 1

4.1 The wall sink in the Men's bathroom is loose. As the sink loosens more through normal use, more and more of the weigh of the sink will be carried by the plumbing pipes. Recommend repairs at this time to limit future damage and costs of repairs.

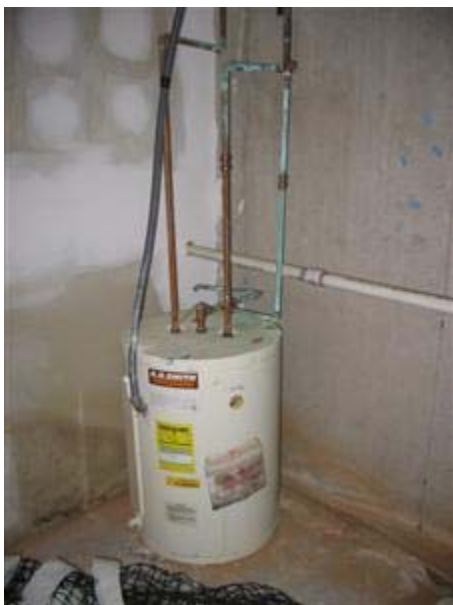
4.3 Picture 1

4.3 The water heater is 18 years old. The average life span of water heaters is 8 to 12 years. Budget for replacement in the near future.

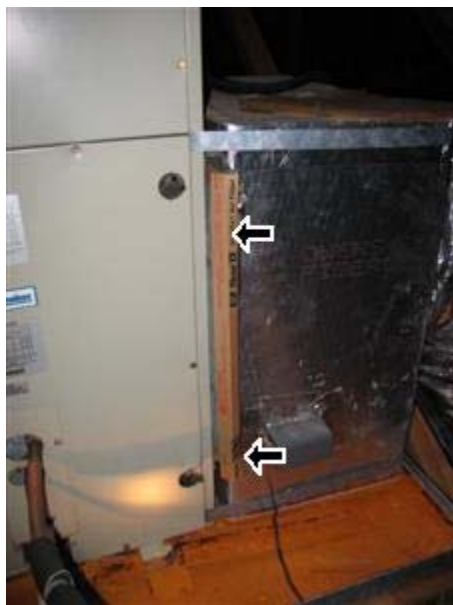
5.3 Picture 1

5.3 The filter on the HVAC system is not the correct size. The filter does not fit into the access hole so that the cover can be installed. Replace the filter with the proper size and replace the cover.

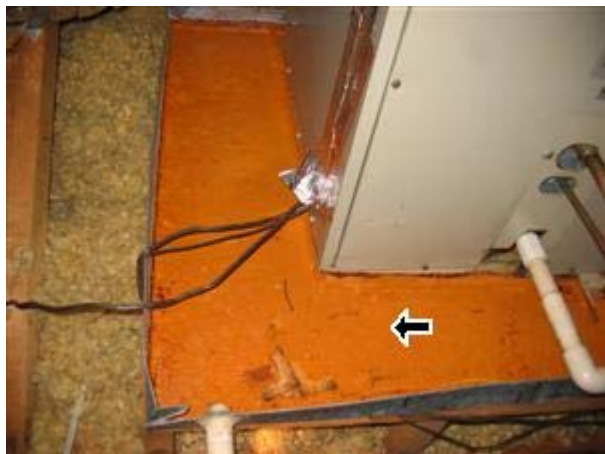
6.0 Picture 1

Observed signs of water in the safety pan under the air handler in the attic. This indicates that the A/C condensation drain is not working properly. Have a licensed HVAC Contractor review and repair this spring before operating the A/C if this problem has not already been addressed.

6.0 Observed signs of water in the safety pan under the air handler in the attic. This indicates that the A/C condensation drain is not working properly. Have a licensed HVAC Contractor review and repair this spring before operating the A/C if this problem has not already been addressed.

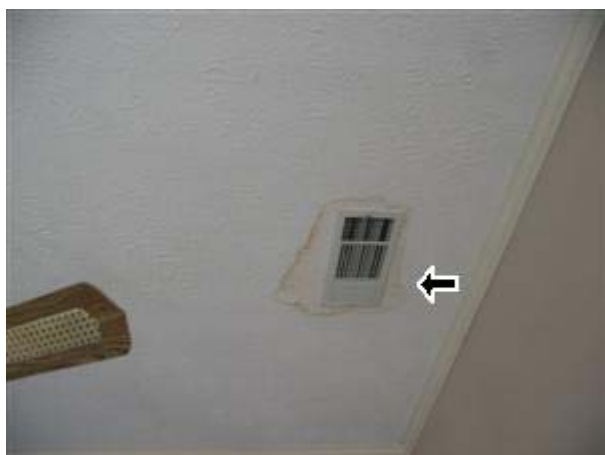
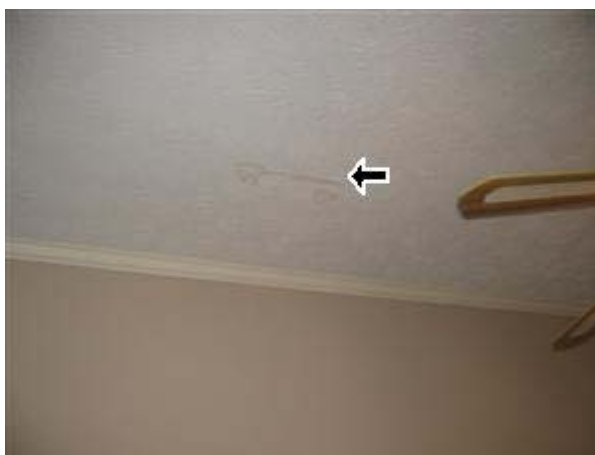
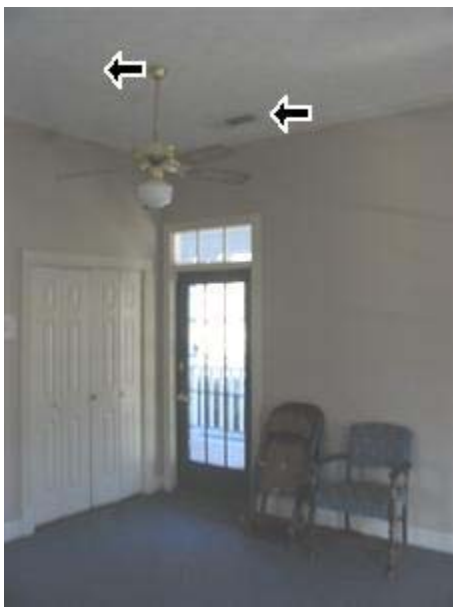
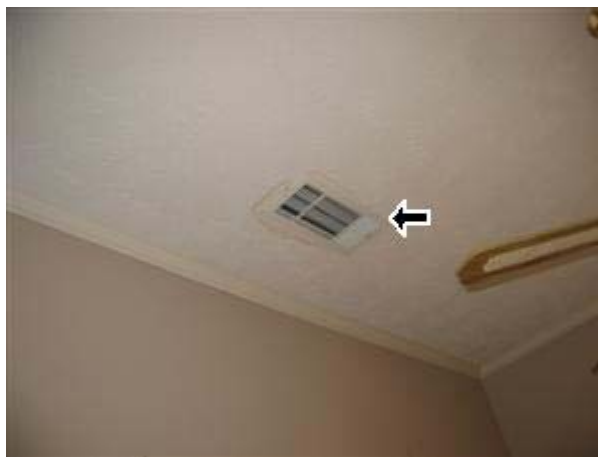
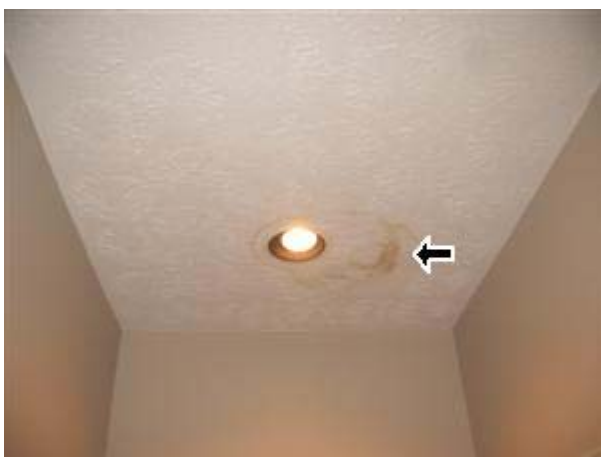
7.0 Water stains visible in the ceilings:

1. At the HVAC register over the entry door near the closets. (Pictures 1-3)
2. In the ceiling at the HVAC register over the exterior door at the left rear corner of the building, on the left side of the building. (Sides of the building are identified on the cover page) (Picture 4)
3. In the hallway ceiling over the water fountain. (Picture 5)

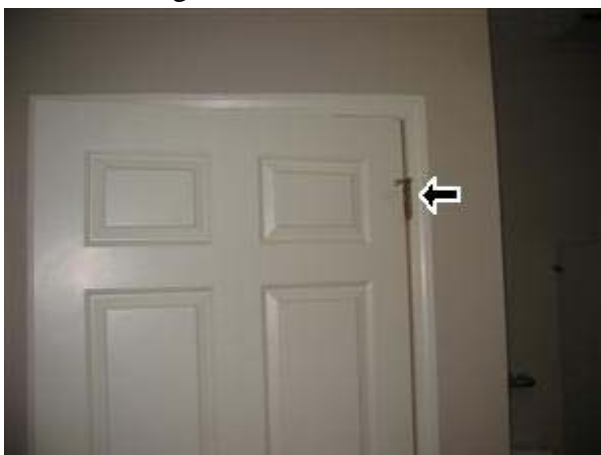
7.3 Picture 1

7.3 Loose hinge on the Men's bathroom door.

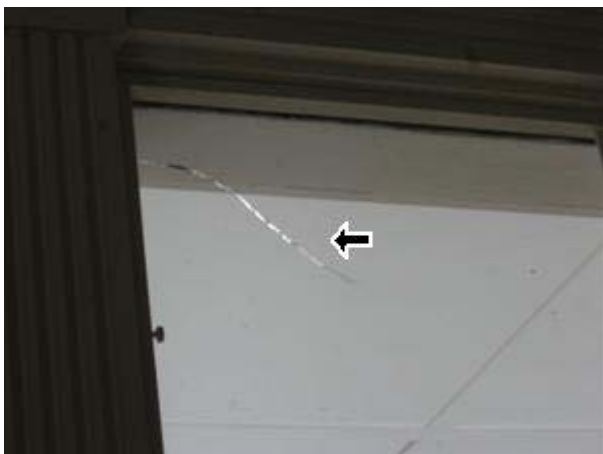
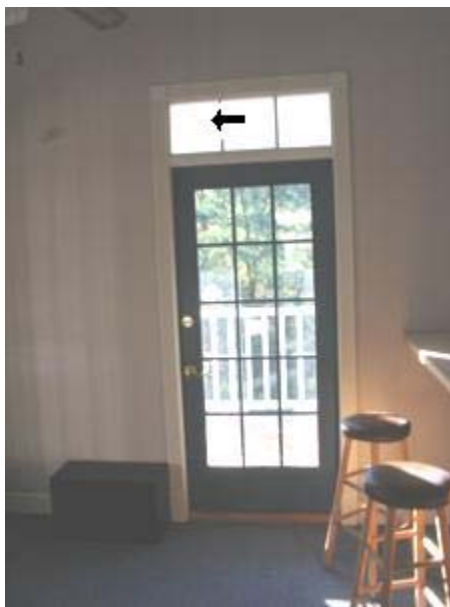
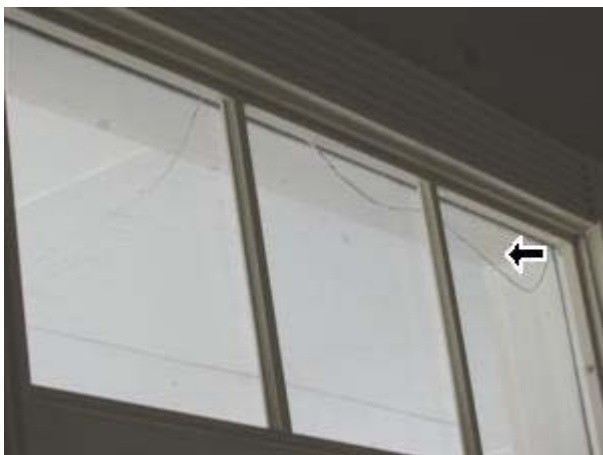
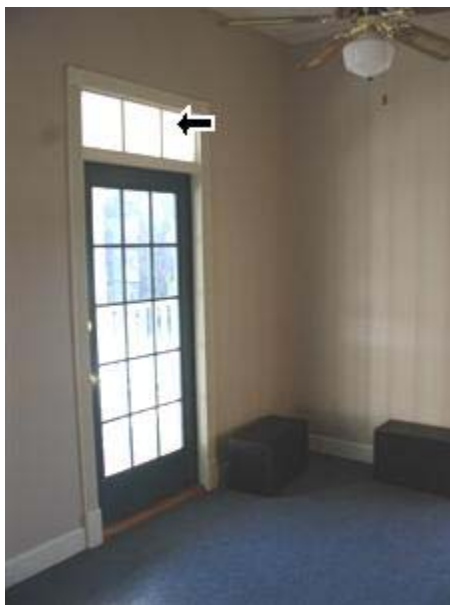
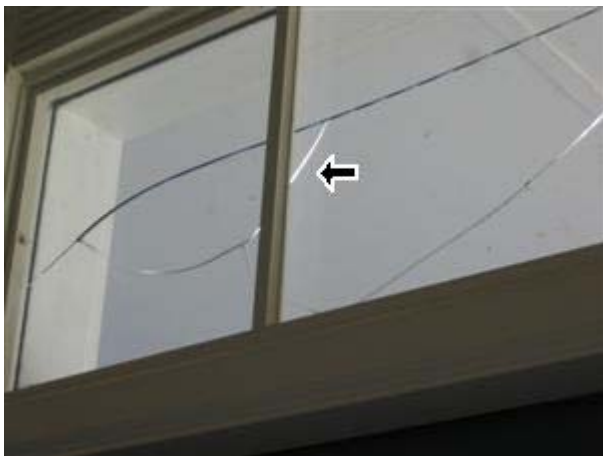
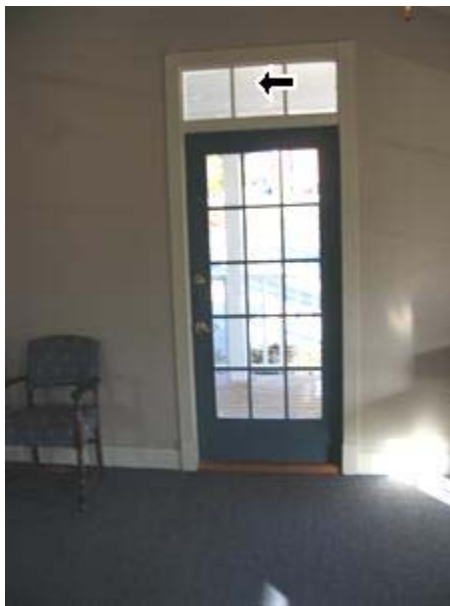
7.4 Broken glass in the transom windows above the exterior doors in 4 of the 6 doors in meeting room.

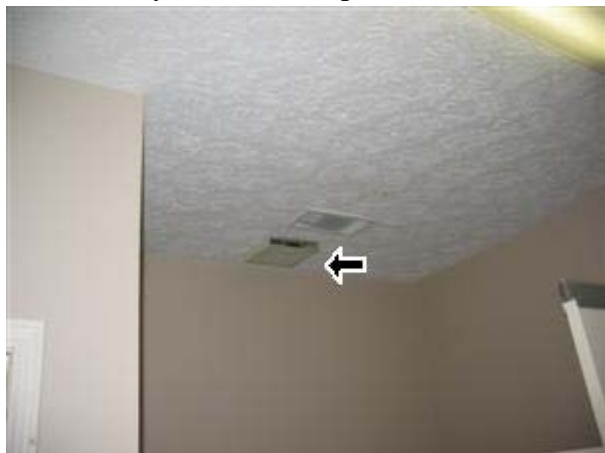
8.2 Picture 1

8.2 The Men's bathroom vent fan has a high level of noise. Clean the fan and check if there is a reduction in noise. This fan may need to be replaced.

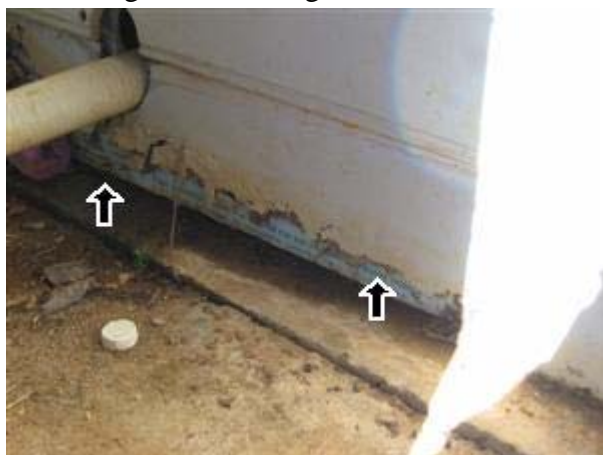
9.0 Picture 1

9.0 Damage to the siding on the rear of the building, behind the A/C unit.

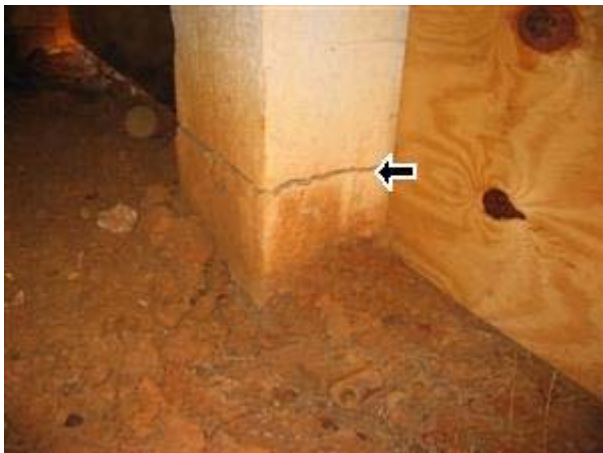
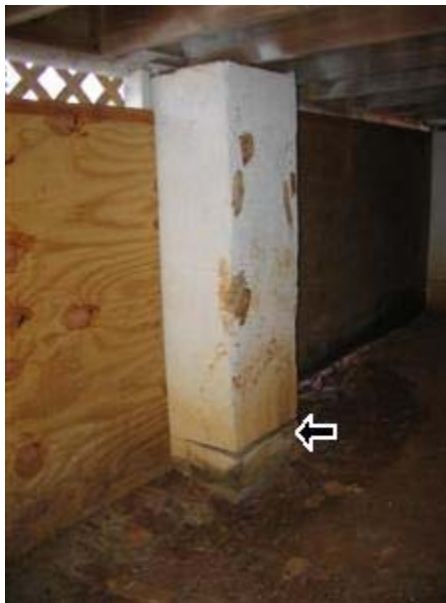
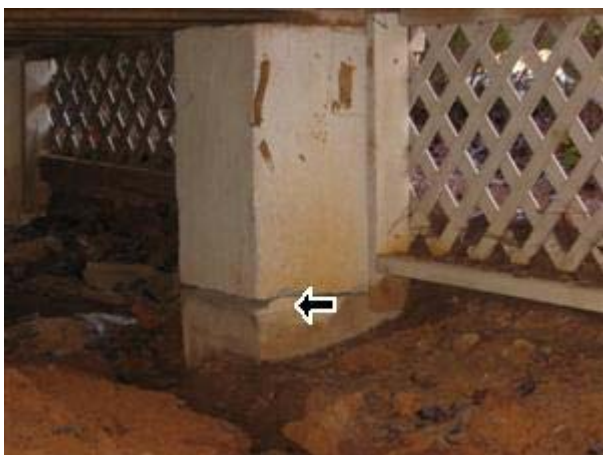
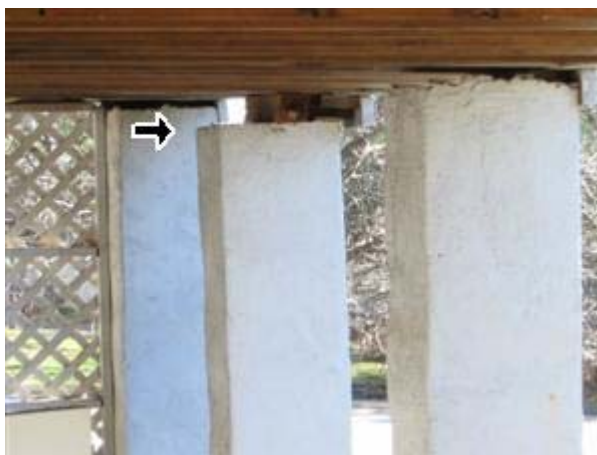
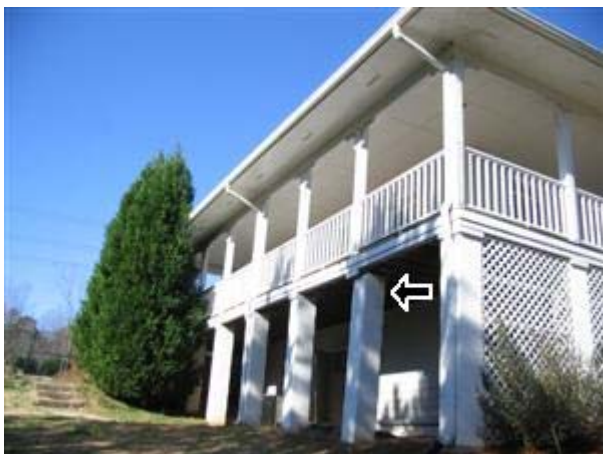
Signs of movement in the piers supporting the deck around the building. Most of the settlement is due to water runoff flowing past the footing.

The piers should be repaired. Cracks in piers were viewed on all sides except the rear side. The tall settling pier is on

the rear side of the building.

The piers should be repaired. Cracks in piers were viewed on all sides except the rear side. The tall settling pier is on the rear side of the building.

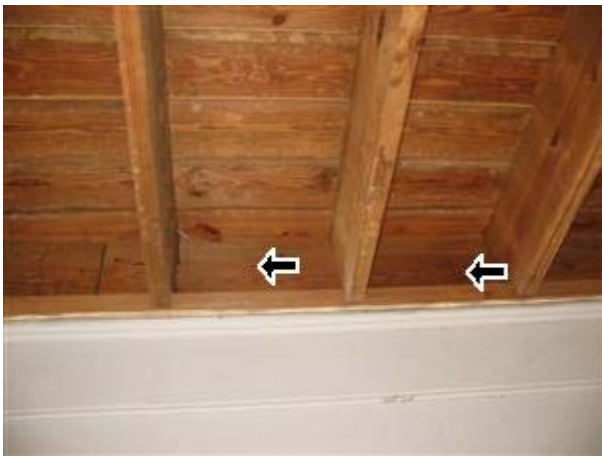
9.5 Picture 1

The deck band is not bolted to the floor framing of the building on any of the 4 sides of the building.

9.5 The deck band is not bolted to the floor framing of the building on any of the 4 sides of the building. Recommend adding bolts to the deck band.

Recommend adding bolts to the deck band.

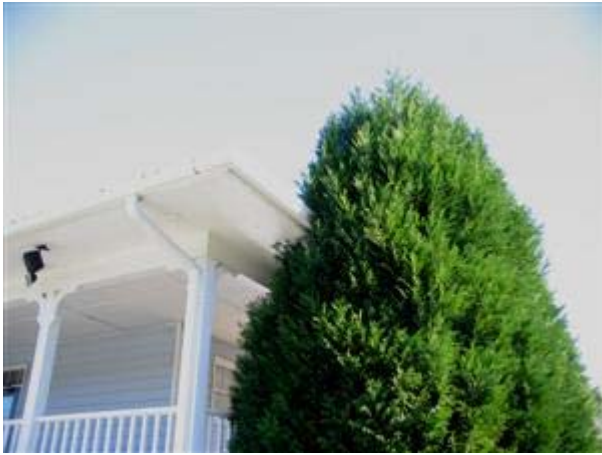
9.6 Picture 1

9.6 Bushes in contact with the roof and gutters. Trim the bush.

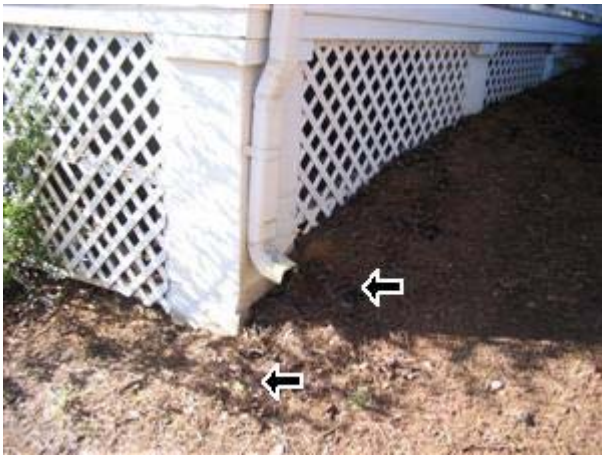
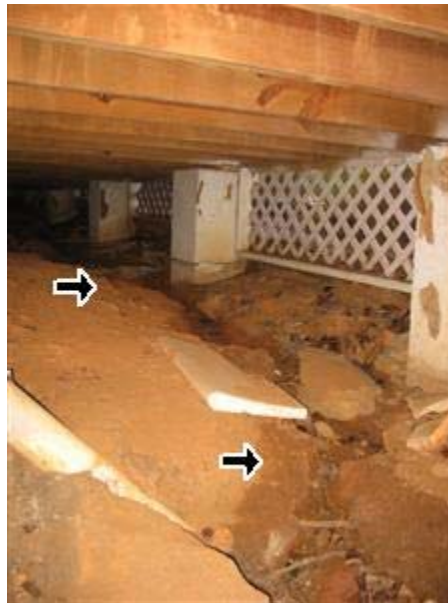
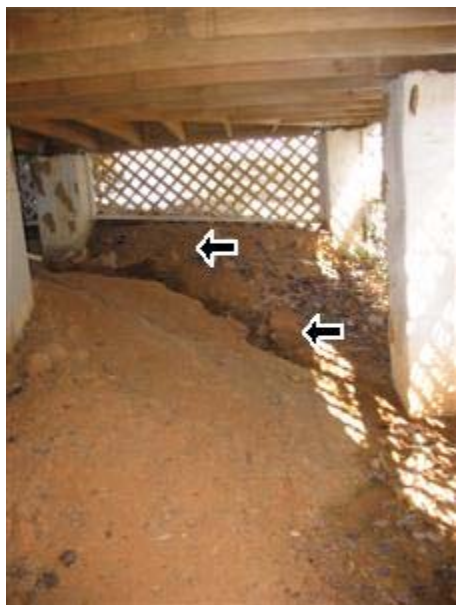
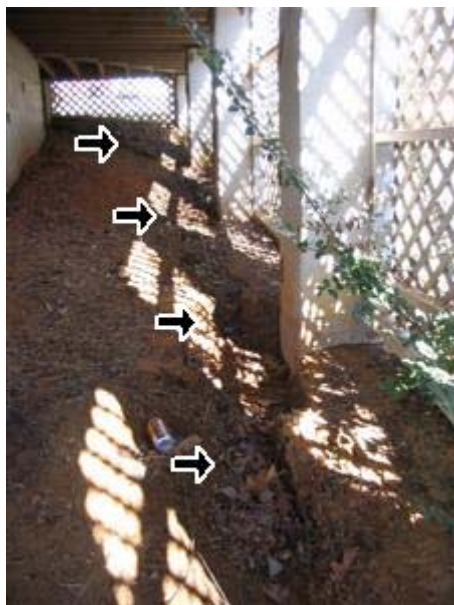
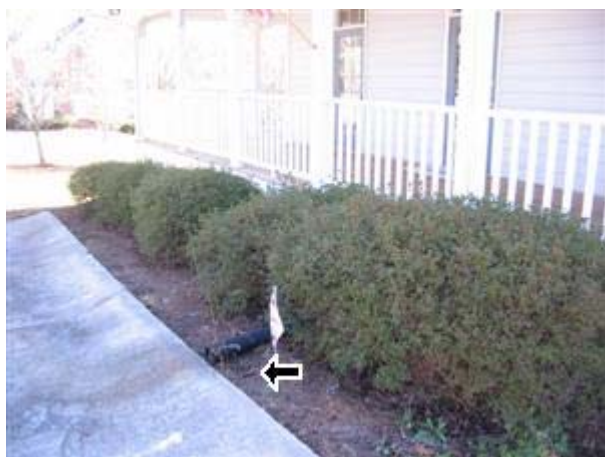
9.7 Recommend extending the downspouts on the left side of the building to the rear, to a point past the deck piers. The runoff from the downspout near the entry ramp is flowing past the pier footings along the front and left sides of the building.

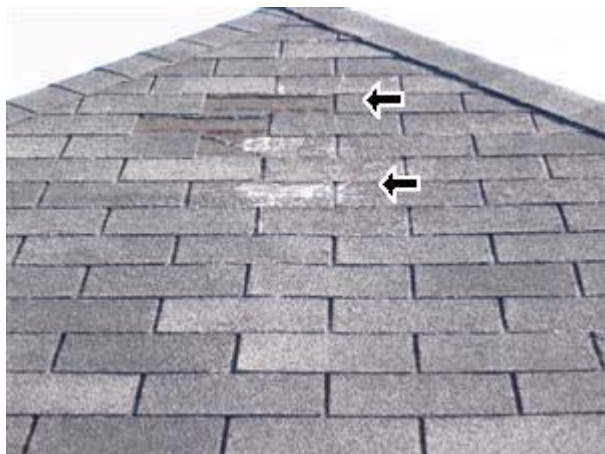
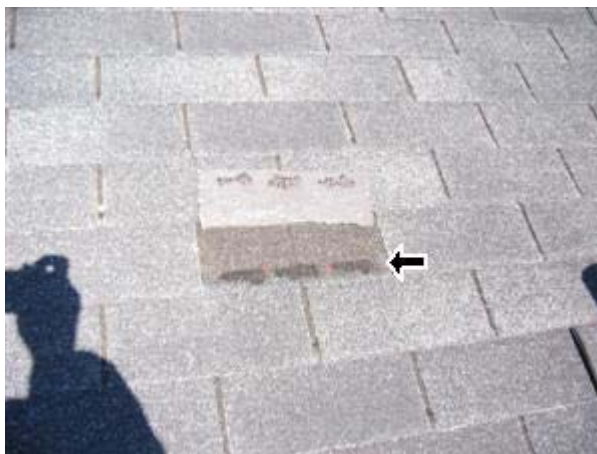
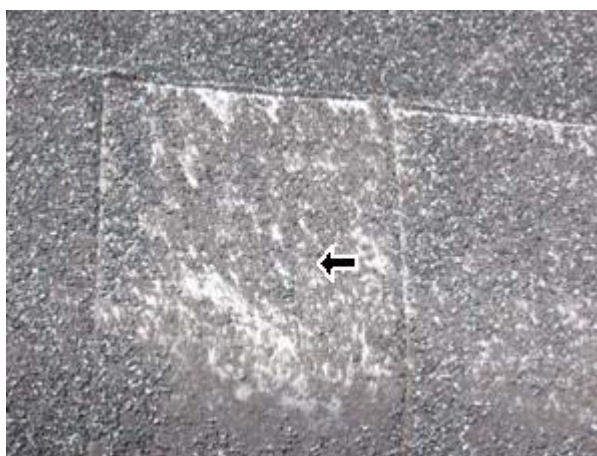
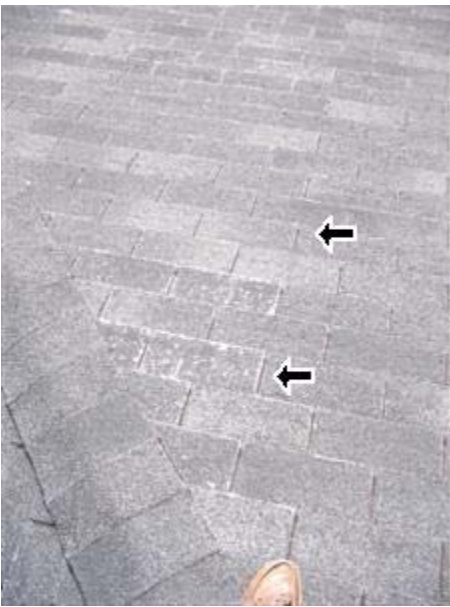
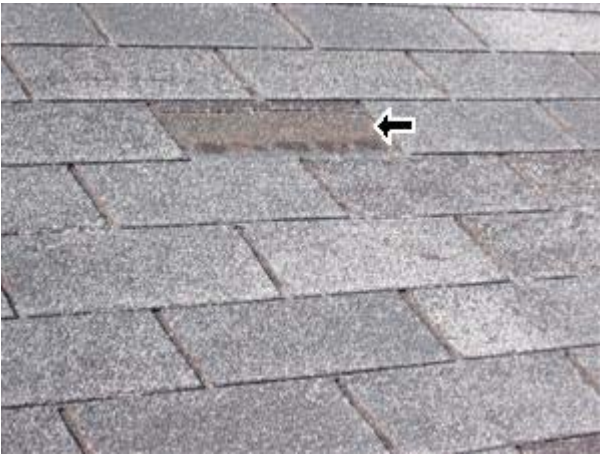
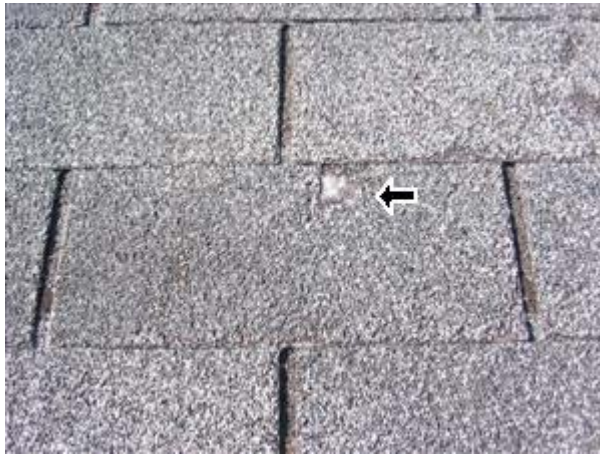
The roof shingles are 18 years old. The average life span of roof shingles in the Atlanta area is 15 to 20 years. There are signs of failure of the roof shingles in several areas around the house.

Present leaks in the roof are also visible.

10.0 The roof shingles are 18 years old. The average life span of roof shingles in the Atlanta area is 15 to 20 years. There are signs of failure of the roof shingles in several areas around the house.

Consult a licensed Roofer on the replacement of the roof.

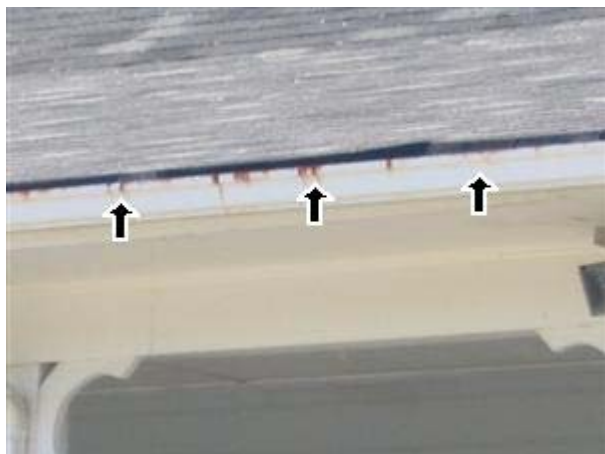
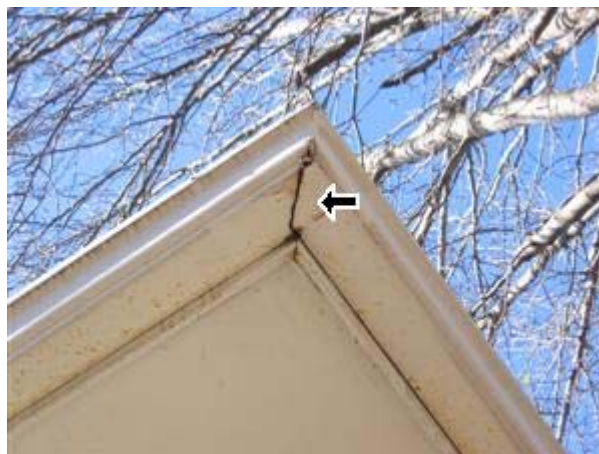
Rust stains visible on the gutters around the building. Rust and gaps in the joints at the corners of the gutters as well. The gutters can be sealed and, if kept clean, they will last a little while longer.

10.1 Rust stains visible on the gutters around the building. Rust and gaps in the joints at the corners of the gutters as well. The gutters can be sealed and, if kept clean, they will last a little while longer.

Budget for gutter replacement in the near future.
